SUBJECT: Transmittal Memorandum for EHB-9 Issuance 02-05

Engineering Handbook No. 9 (EHB-9), Automatic Radiotheodolite (ART - 1/2), Section 3.4, Modification Note 18, 10.7 Megahertz (MHz) Test Point R/ACU Test Panel Rewiring.

ART MODIFICATION NOTE 18 (for Electronics Technicians)

SUBJECT : 10.7 Megahertz (MHz) Test Point R/ACU Test Panel Rewiring

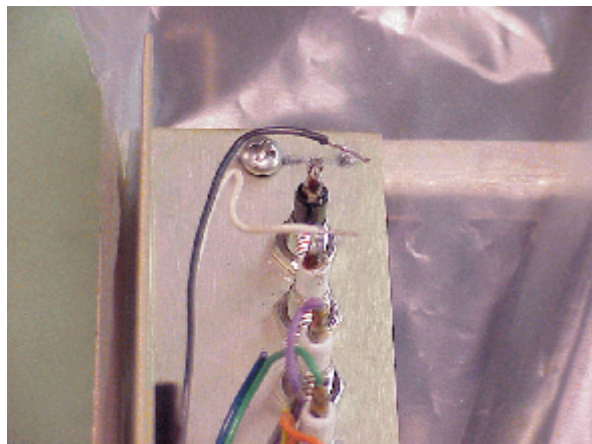
**Figure 1**

The existing 10.7 MHz test point wire is not shielded and has shown to cause a false oscilloscope reading. The MIL-C-17 cable included in the modification kit, provides a true 1.8 volt oscilloscope representation.

7. Carefully unsolder the white lead from the "10.7 MHz" test point (figure 1).
8. Disconnect the other end of the white wire attached to XA2-1 (figure 2).
9. Remove the black (ground) wire from the "SIG GND" test point (figure 1).
10. Locate the Belden cable #83284 in the modification kit and carefully separate the ground shield from the center conductor (figure 3).
11. Take the black wire unsoldered in step 9 and twist it together with the ground shield of the Belden cable.
12. Solder both wires to "SIG GND" test point (figure 4).
13. Take the center conductor of the new Belden Cable #83284 and solder it to the 10.7 MHz test point (figure 4).
14. Remove the self-tap screws, flip the test panel over, and slide it back into slot A1.
15. Using the self-tap screws, secure the panel to the card cage.
16. Route the new Belden cable under the test panel and between PS2 to the A7 board.
